NAFLIC

001 Safety Alert

SAFETY ALERT/ACTION NOTE

KOLMAX PLUS MIAMI TRIP

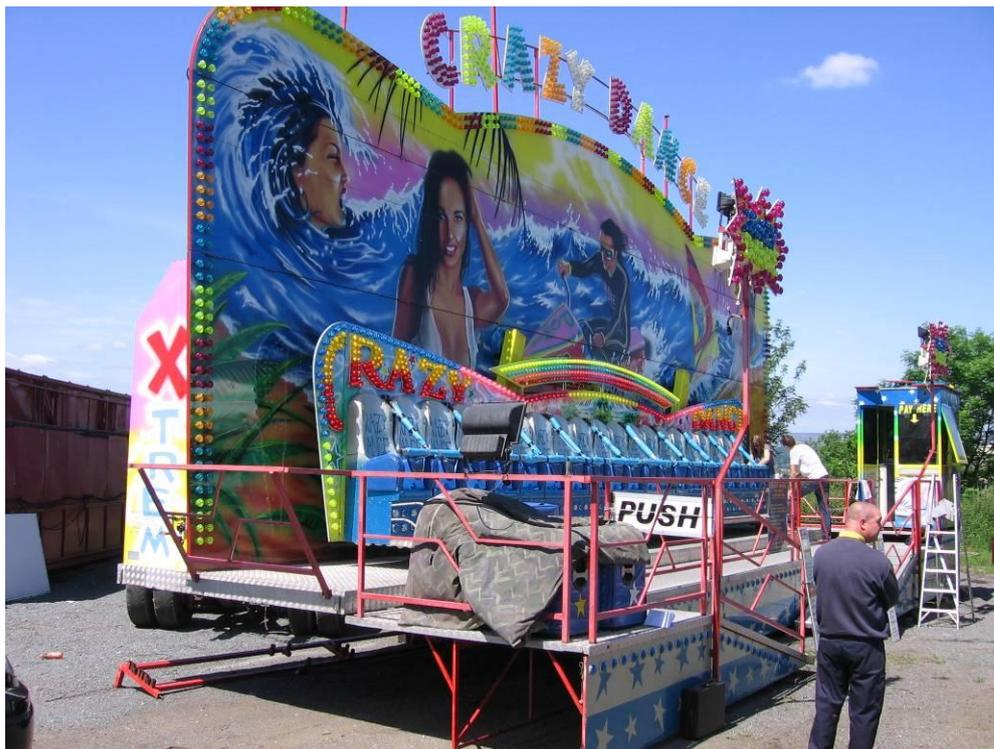
On 12 June 2010 at Halifax a young, disabled person was injured when they were ejected from the right hand end seat a 20 seat Kolmax Plus Maimi Trip ride. The ride had been manufactured in the Czech Republic in 2004. See Fig 1.

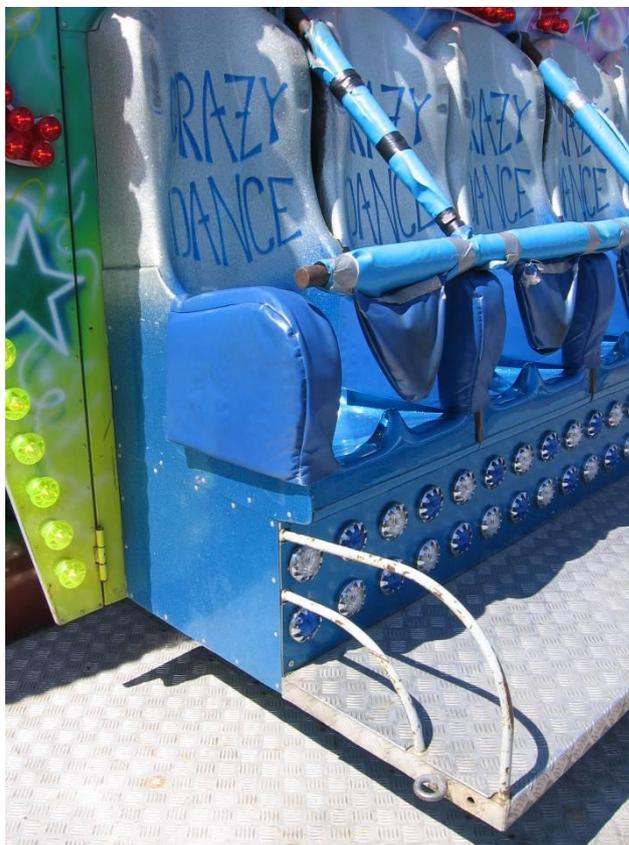
Fig 2.

It is believed that at the time of the accident the overhead restraint bars were properly fastened. It is probable that the injured person came out of the ride when her upper

body moved forward of the existing shoulder restraint and then the natural movement of body weight caused her to topple over the side of the seat and then out of the ride (see fig 2).

Action Required - 1: With immediate effect no passengers should be seated in the last outside seats of these devices, on either side, until a supplementary restraint system/bars has been fitted to prevent a person being ejected from the ride. It is understood that design review work in this area has been started by the showman involved in this incident in consultation with an ADIPS approved design reviewer. The restraint system or bars should be fitted so that they do not cause any trapping hazard and should be padded to prevent injuries when riders contact them during the ride.

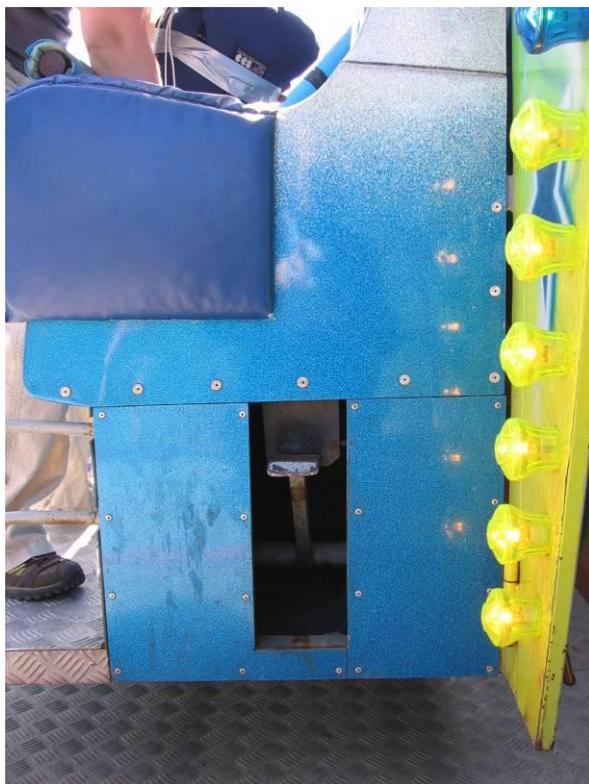
Action Required – 3: At the end of the ride cycle the restraint bars are released by the operator pushing down a pedal on the side of the gondola. See Fig 3. This pedal can be reached and activated by the passenger sitting in the end seat nearest the pedal. This access is to be prevented. This may be done by fitting a shroud around the pedal housing so that passengers cannot reach the pedal or by designing the restraint bars mentioned above such that they prevent passengers reaching the pedal.

Any shroud should not be fitted such that it creates a further risk to the operator when unloading the ride.
