NAFLIC

005 Safety Alert

SAFETY ALERT/ACTION NOTE

KOLMAX PLUS MIAMI TRIP

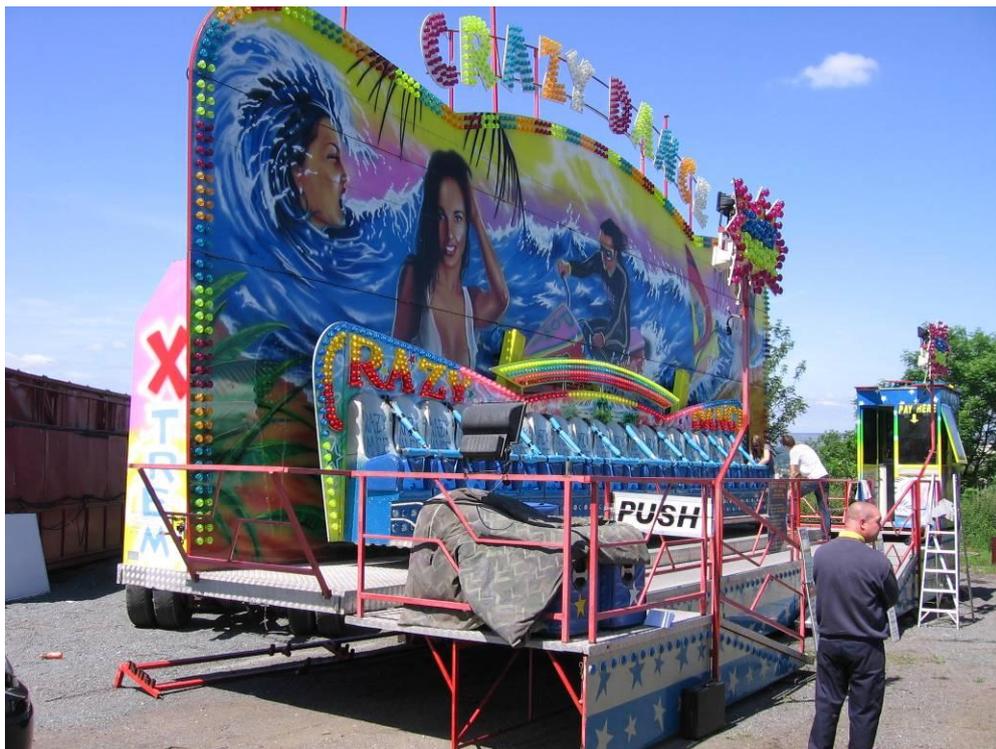
On 12 June 2010 at Halifax a young, disabled person was injured when they were ejected from the right hand end seat a 20 seat Kolmax Plus Maimi Trip ride. The ride had been manufactured in the Czech Republic in 2004. See Fig 1.

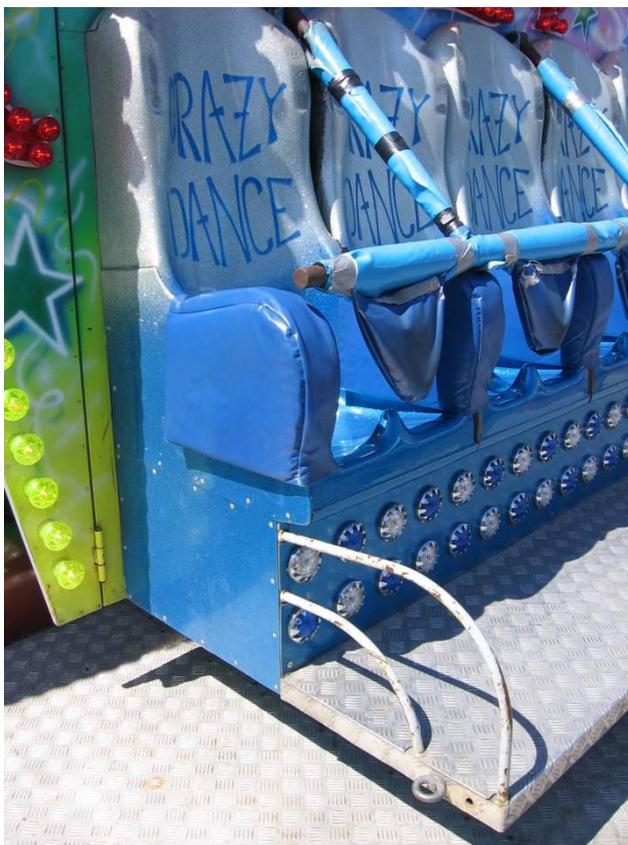
Fig 2.

It is believed that at the time of the accident the overhead restraint bars were properly fastened. It is probable that the injured person came out of the ride when her upper body

moved forward of the existing shoulder restraint and then the natural movement of body weight caused her to topple over the side of the seat and then out of the ride (see fig 2).

Action Required - 1: With immediate effect no passengers should be seated in the last outside seats of these devices, on either side, until a supplementary restraint system/bars has been fitted to prevent a person being ejected from the ride. It is understood that design review work in this area has been started by the showman involved in this incident in consultation with an ADIPS approved design reviewer. The restraint system or bars should be fitted so that they do not cause any trapping hazard and should be padded to prevent injuries when riders contact them during the ride.

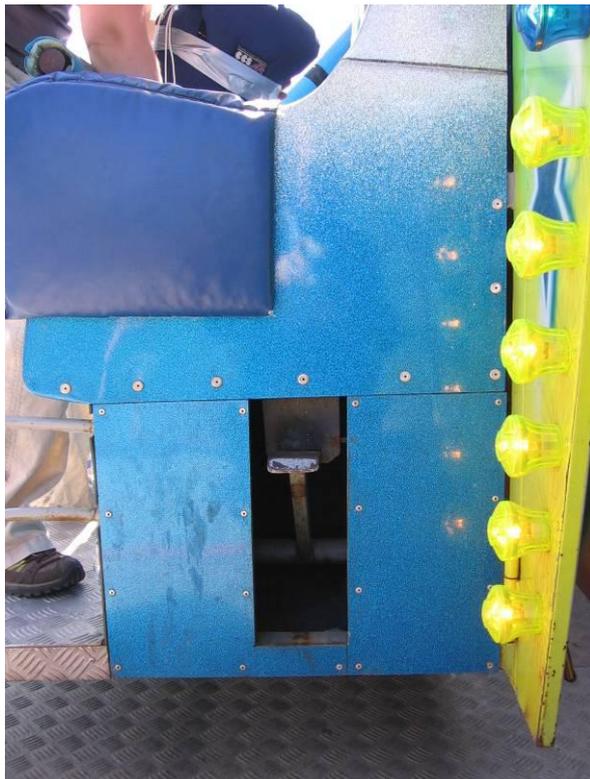
Action Required – 3: At the end of the ride cycle the restraint bars are released by the operator pushing down a pedal on the side of the gondola. See Fig 3. This pedal can be reached and activated by the passenger sitting in the end seat nearest the pedal. This access is to be prevented. This may be done by fitting a shroud around the pedal housing so that passengers cannot reach the pedal or by designing the restraint bars mentioned above such that they prevent passengers reaching the pedal.

Any shroud should not be fitted such that it creates a further risk to the operator when unloading the ride.
