NAFLIC

TECHNICAL BULLETIN - JUNE 1993

059. Pinfari ZL Series Roller Coasters

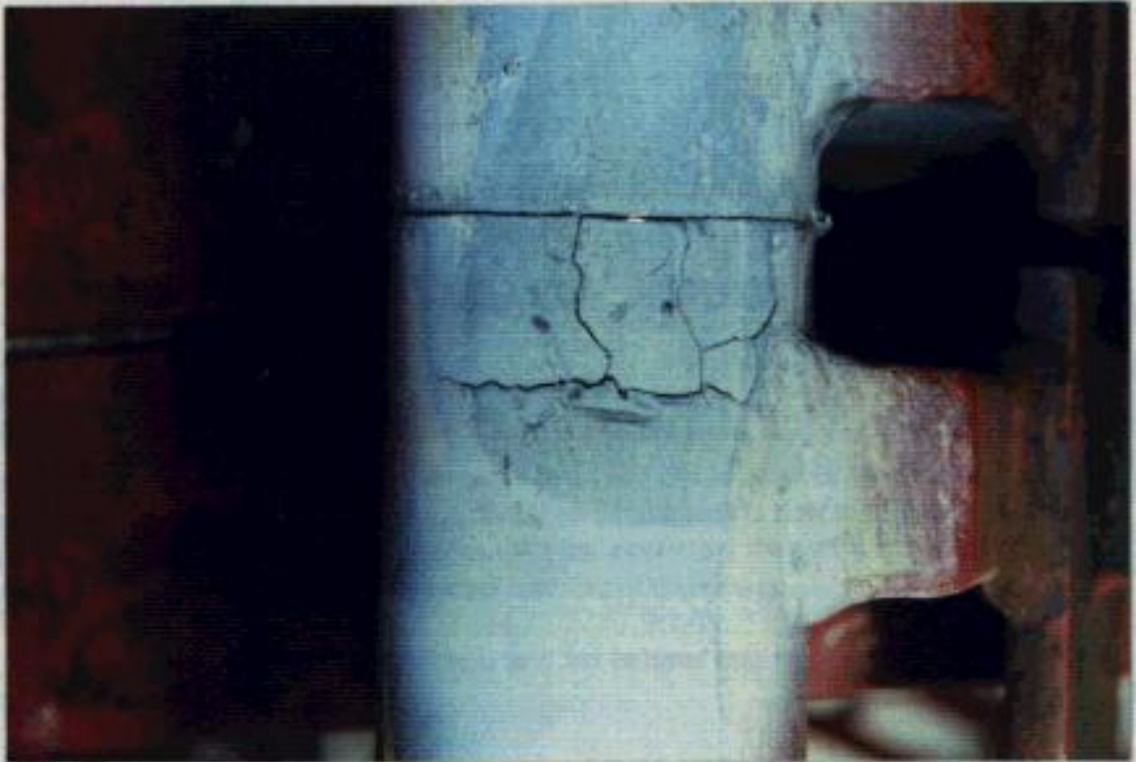
Earlier this year NAFLIC members Morgan-Ward (NDT) Ltd sent in the attached photographs to the Secretary. The pictures show detail of fatigue cracks near a rail track joint of a Pinfari Looping Coaster from their ZL series. We are aware that the problem has been identified at the highest loaded joints of some other coasters of this design.

Figure 1. Cracked and pitted surface of the pipe.

It is the manufacturer's opinion that the highest loaded joints should be inspected visually by ride operators. There should also be periodic NDT. We are in agreement with this advice.
