NAFLIC

TECHNICAL BULLETIN — February 2015

388. Huss Enterprise/UFO boom cracking

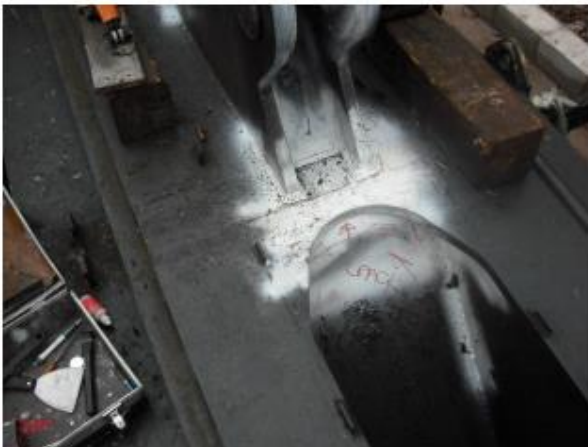
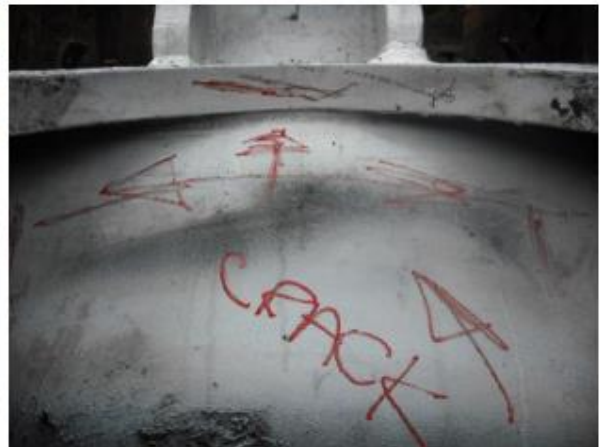
The cracking is located below the upper ram attachment area and under the main boom plate. Both areas of cracking that have been found are between 370mm - 390mm long and were both found visually and then subjected to MPI to establish the full length of the crack.

One of the devices was inspected with the ram removed and the other with the ram in place; on both devices the cracking was easily found.

It is understood Huss has issued a repair procedure that incorporates additional strengthening plates. Please see photographs below.
