446.

J4 Rides Jumping Jack

We have received a report from a UK registered inspection body relating to a Jumping Jack juvenile lift and drop pneumatic powered device, manufactured by J4 rides in the year 2000.

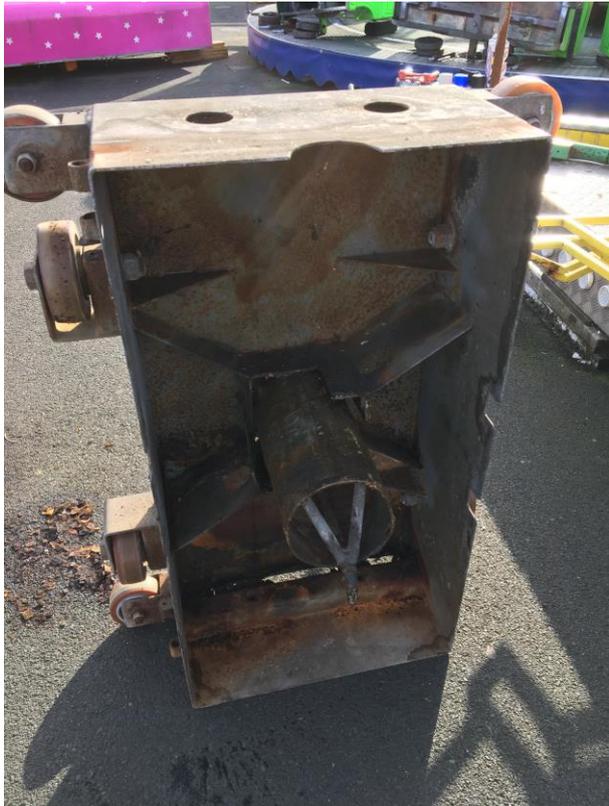
Trolley removed from device.

The IB has advised that the trolley should be removed to aid inspection.

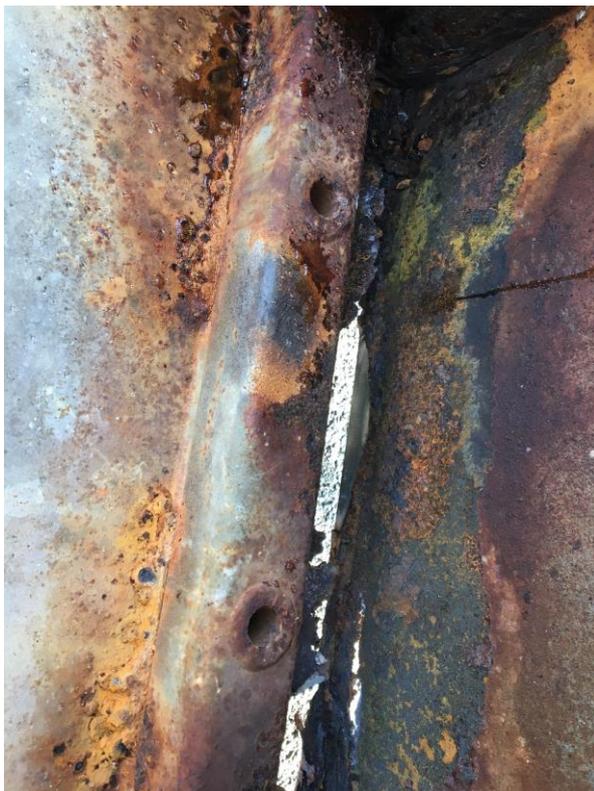
The device trolley was inspected as part of the annual inspection. The lower steel plate section showed signs of visible surface corrosion and was subjected to UT thickness scans which highlighted a dramatic reduction in wall thickness to the lower plate, side walls and lower box section, which secures the lifting ropes.

Corrosion to plate and box section seam.

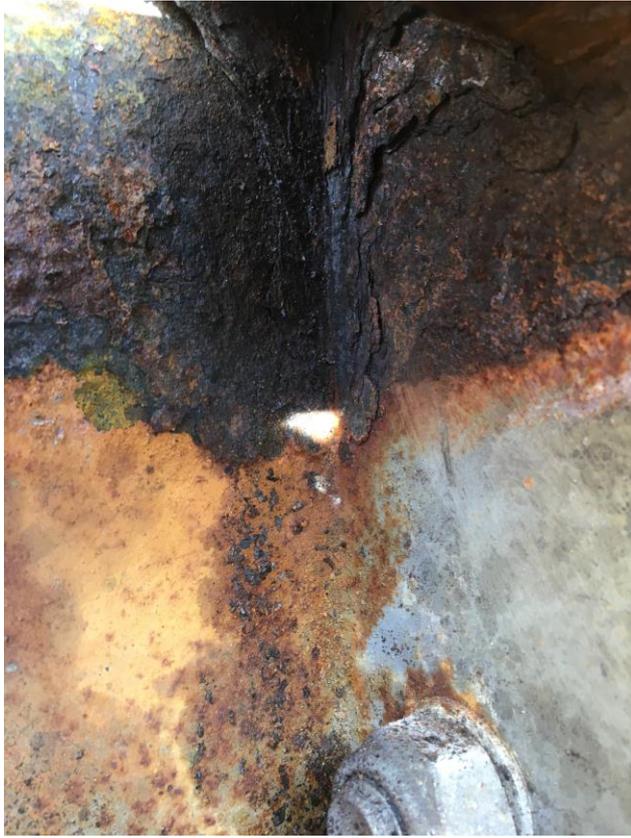
Corrosion to lower corner sections.

Plate wall reduction from 2.5mm to 1mm average.
