## 458.

# Intamin raft boat lifting bolt failure

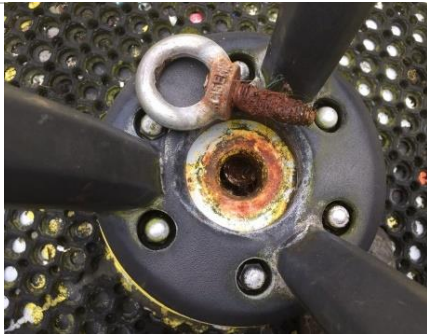
Figure 1

1. The lift eyelet bolt and its threaded connection point had suffered from corrosion and sheared during lifting operations (figure 1).
2. The raft GRP around the lifting eye had suffered from UV degradation with the eyelet assembly detaching from the boat's GRP.

Given the nature of use and level of strip required to access these components, it may be possible to risk assess and mitigate the risk of failure through the implementation of safe alternative lifting and transportation practices. Known examples include the use of boat lifting frames (figure 2 shows an example), ground transportation via crate rather than suspension and limiting the use of existing lifting eyes to only lift boats clear of the floor.
