474.

## Galloper crank failure

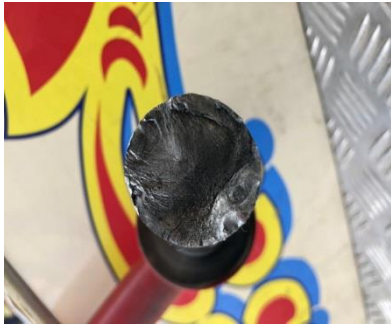
Figure 1

A UK registered inspection body has reported the failure of a Galloper crank (as per images 1-3) manufactured by John H. Rundle, on a ride built by another manufacturer.

The crank design incorporated welded washers on either side of the horse pole bearing to keep the bearing in position during operation.

The failure occurred directly under the bearing side washer. It is understood that the cranks had been subjected to annual inspection, but due to the washer being welded to the crank the critical area directly under the washer cannot be subjected to inspection. The manufacturer has been contacted and informed of this failure/design issue.

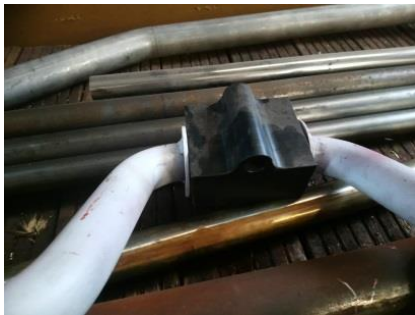
Figure 4  
Bearing assembly

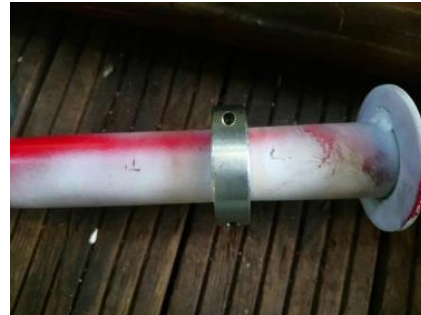
Figure 5  
New clamp design

Following their investigation into the cause of the failure, the manufacturer has redesigned the way the bearing is held in position by using clamps (image 5) either side of the bearing instead of the welded washer to retain the bearing in position.

As this is a change to the original design this modification should be subjected to pre-use inspections.
