475.

## Kolmax Plus s.r.o. Flying Dumbos radial arm cracking

A UK registered inspection body has reported defects that have been found on the radial arms of a Kolmax Plus s.r.o. (Czech Republic) Flying Dumbos.

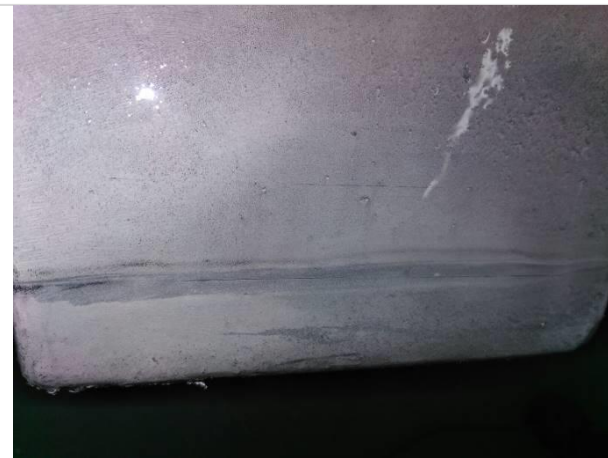
Figure 3  
Cracking still present after grinding to a depth of 1.5mm

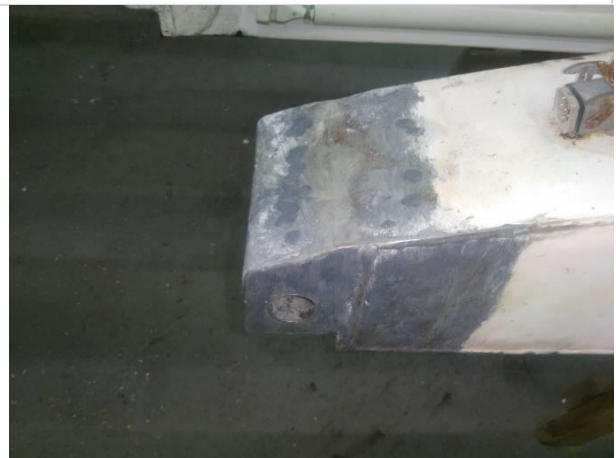
Figure 4  
Area of paint removal
