NAFLIC

TECHNICAL BULLETIN - MAY 2003

258. PWS Twist Cracking

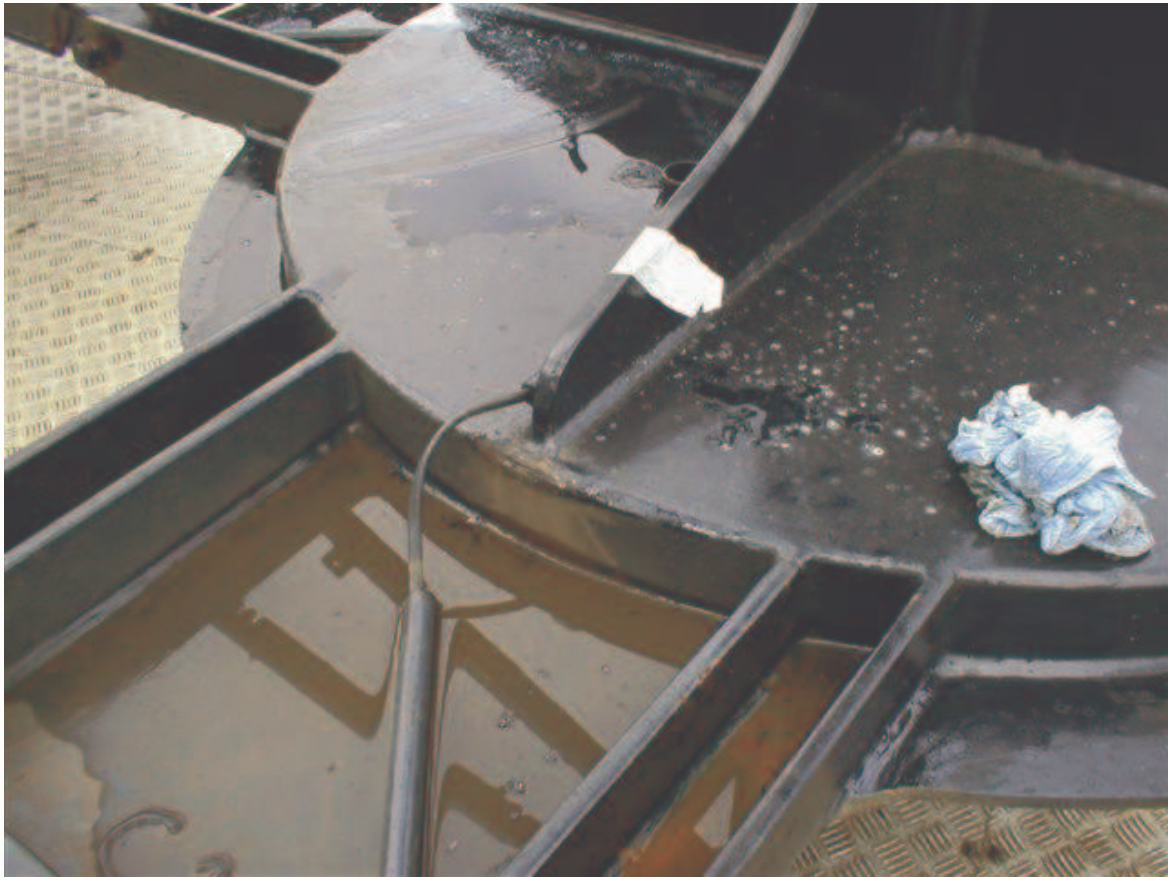
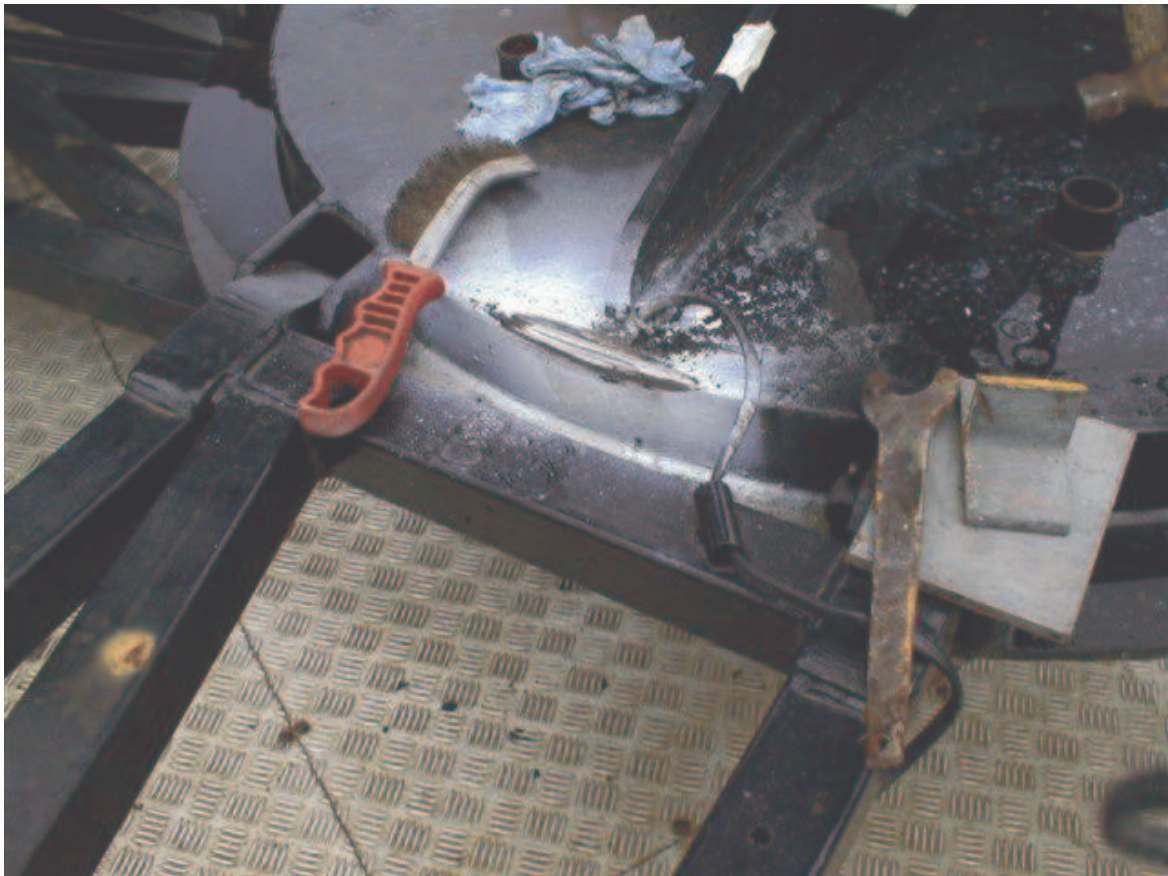
258. PWS Twist Cracking

At the level of the horizontal car arms, each capstan has two large horizontal circular plates spaced about 50 mm or so horizontally apart by a vertical rolled steel ring. The lower of these discs is approximately 150 mm greater in diameter than the upper one. The top edge of the spacer ring is welded to the circumference of the smaller, top, disc and the lower edge is welded onto the surface of the larger, bottom, disc. There are 4 vertical gusset plates, 90° apart, attaching onto the top surface of each upper disc, and terminating some 20 mm or so short of the outer edge. At this region, some localised bending of the disc is likely to occur, translating into increased stress at the weld connecting the ring to the disc.

Tony Mogford Associates, using MPI, have detected 8 cracked welds (variously 20, 30, 60, 65, 70, 70, 80 and 95 mm long). The region in question is very accessible and visible and, at the stage detected, the cracking was probably not imminently dangerous. However, it would be unwise to leave such cracking undetected and unrepaired.
