002 - Safety Alert

HSE Action Notice - ROLLER COASTER BRAKING SYSTEM

ROLLER COASTER BRAKING SYSTEM

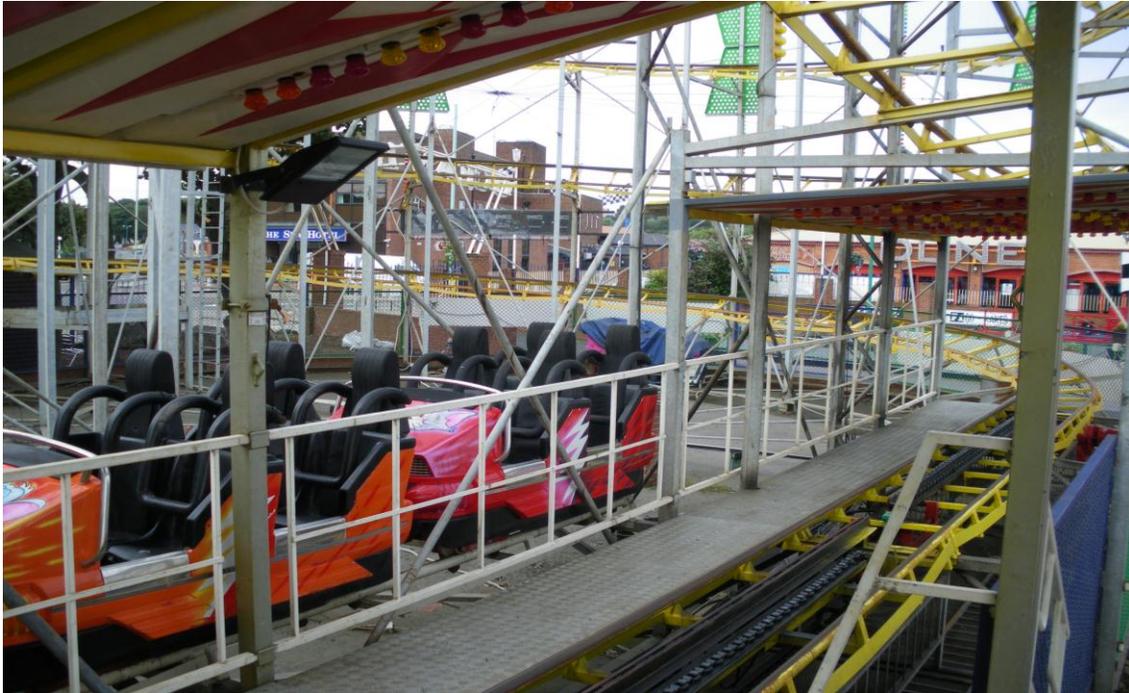
Fig 1:

The ride involved in the accident is a Pinfari Zyklon Roller Coaster **but it is possible that similar brake control systems may have been fitted to other coasters.** A general view of the station area is at Fig 1.

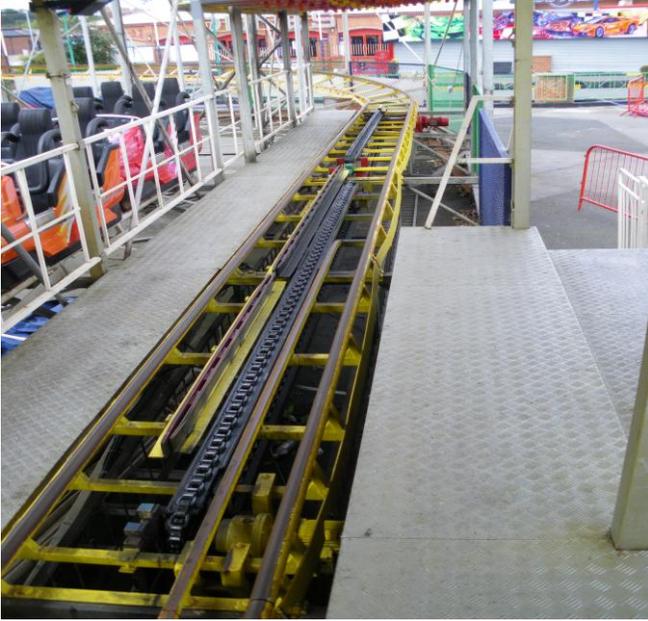
Cars arriving back in the station are, under normal conditions, slowed and stopped by a chain brake system. In certain circumstances however ie when the car is carrying more than average weight or running in wet conditions this chain brake may not be sufficient to bring the car to a complete stop and a secondary air brake is used. This may be operated either manually or automatically. A general view of the braking area is shown at Fig 2.

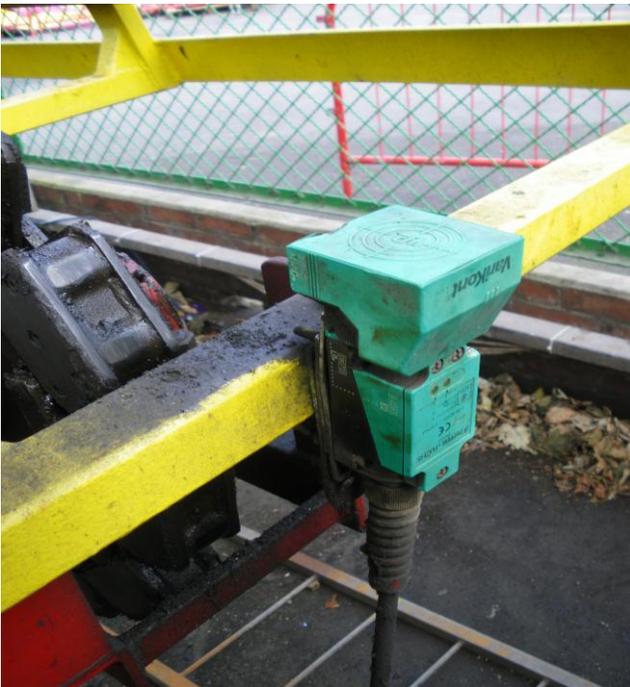
The coaster involved in the accident had a retro fitted automated secondary air brake, operated by proximity sensors fitted to the track in the braking area. An example of such a sensor is at Fig 3 and Fig 4 shows one of the pair of sensors fitted to the track.

1. Controllers using roller coasters with such sensor controlled systems should ensure that this secondary braking system is working correctly.
2. Testing of this system should form part of the daily checks on the ride and the tests should be conducted with realistic load weights in the cars.

3. Controllers should discuss with their ride inspectors the feasibility of changing this single sensor system to a parallel wired reserve sensor system or to a system able to detect state changes across pairs of sensors.

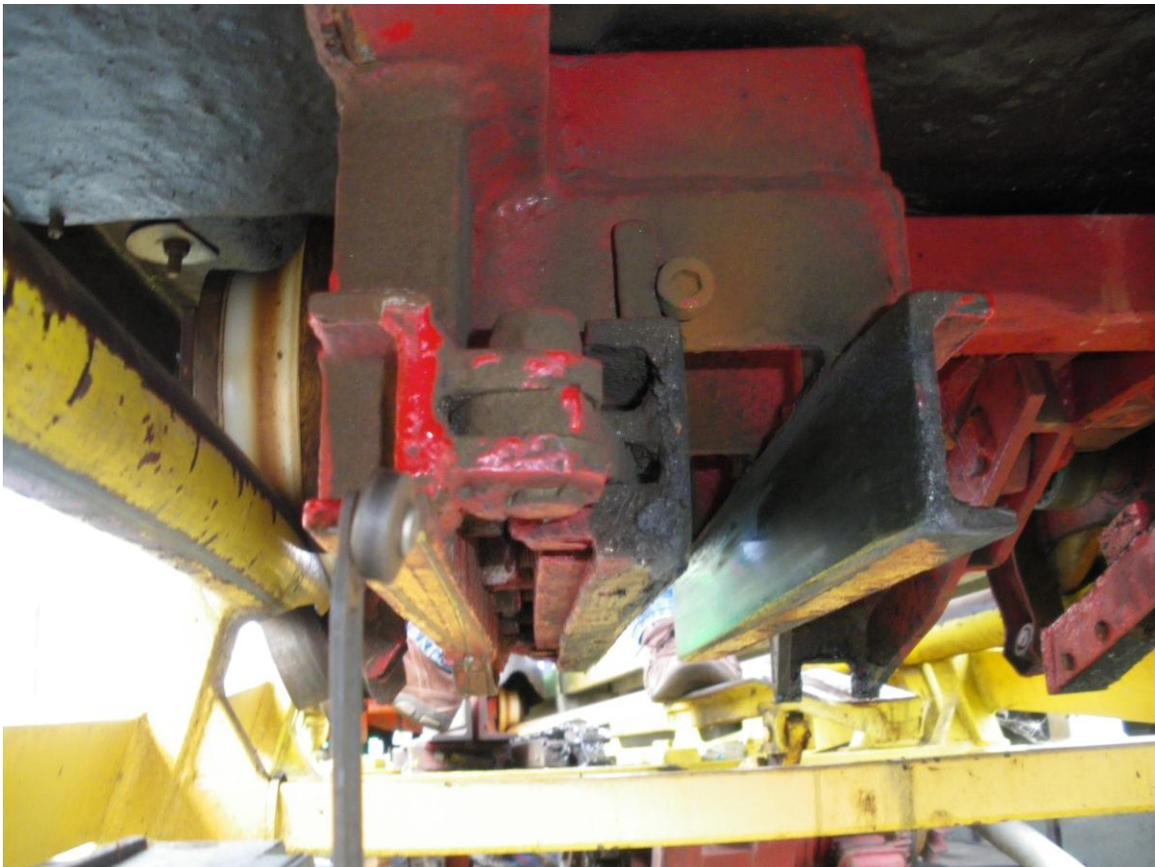
Fig 4.

Fig 4 is a photo taken underneath a car showing the metal plates which engage the chain brake system and it is also these plates that operate the sensors when necessary
