TECHNICAL BULLETIN — AUGUST 2010

363. HSE Action Notice – Roller Coaster Braking System

ACTION NOTE

ROLLER COASTER BRAKING SYSTEM

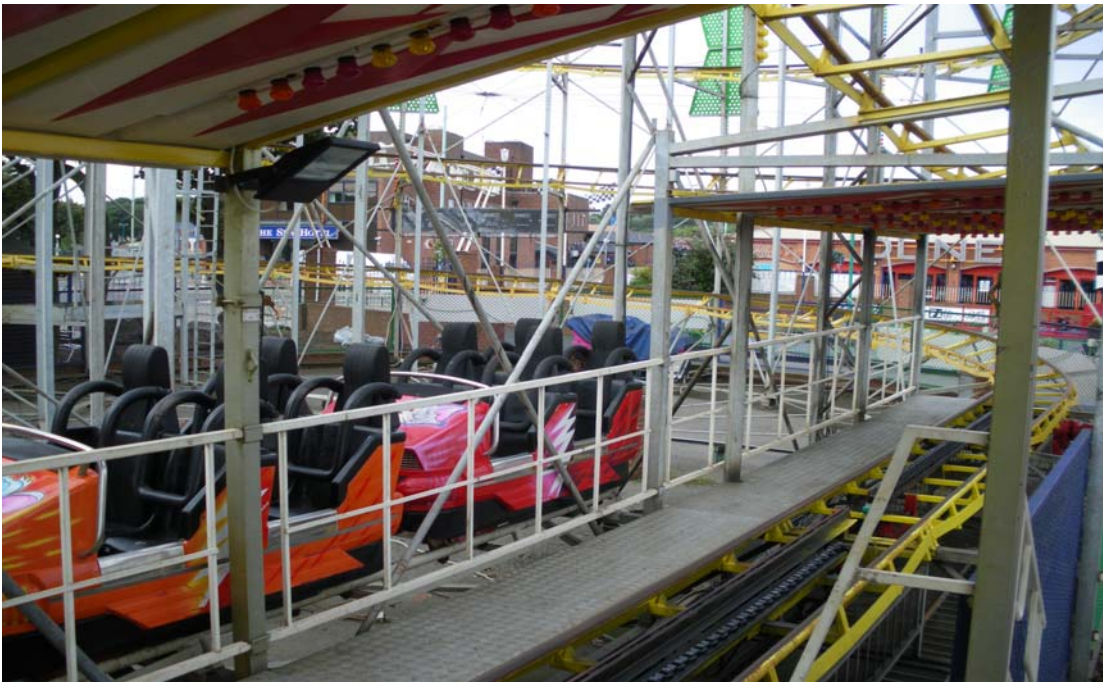
Fig 1:

The ride involved in the accident is a Pinfari Zyklon Roller Coaster **but it is possible that similar brake control systems may have been fitted to other coasters.** A general view of the station area is at Fig 1.

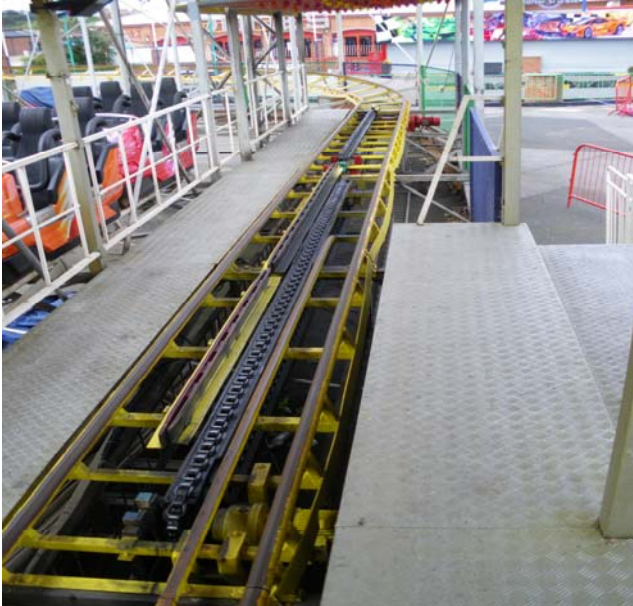
Cars arriving back in the station are, under normal conditions, slowed and stopped by a chain brake system. In certain circumstances however ie when the car is carrying more than average weight or running in wet conditions this chain brake may not be sufficient to bring the car to a complete stop and a secondary air brake is used. This may be operated either manually or automatically. A general view of the braking area is shown at Fig 2.

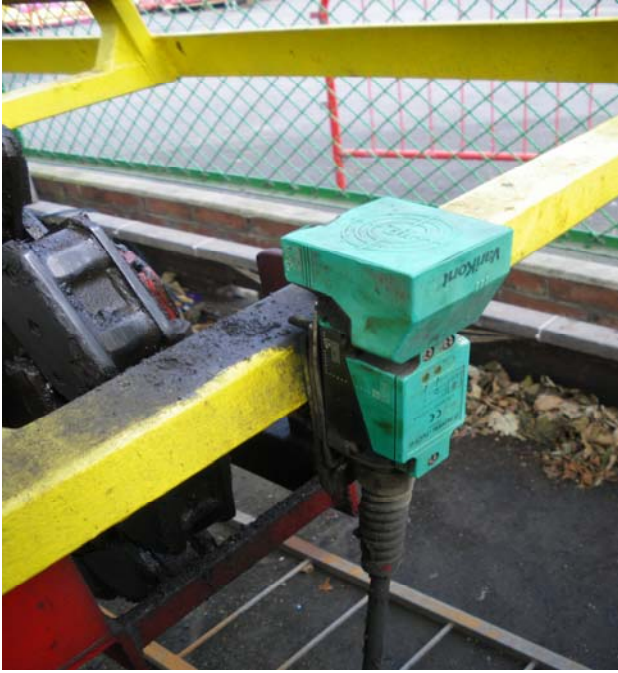
The coaster involved in the accident had a retro fitted automated secondary air brake, operated by proximity sensors fitted to the track in the braking area. An example of such a sensor is at Fig 3 and Fig 4 shows one of the pair of sensors fitted to the track.

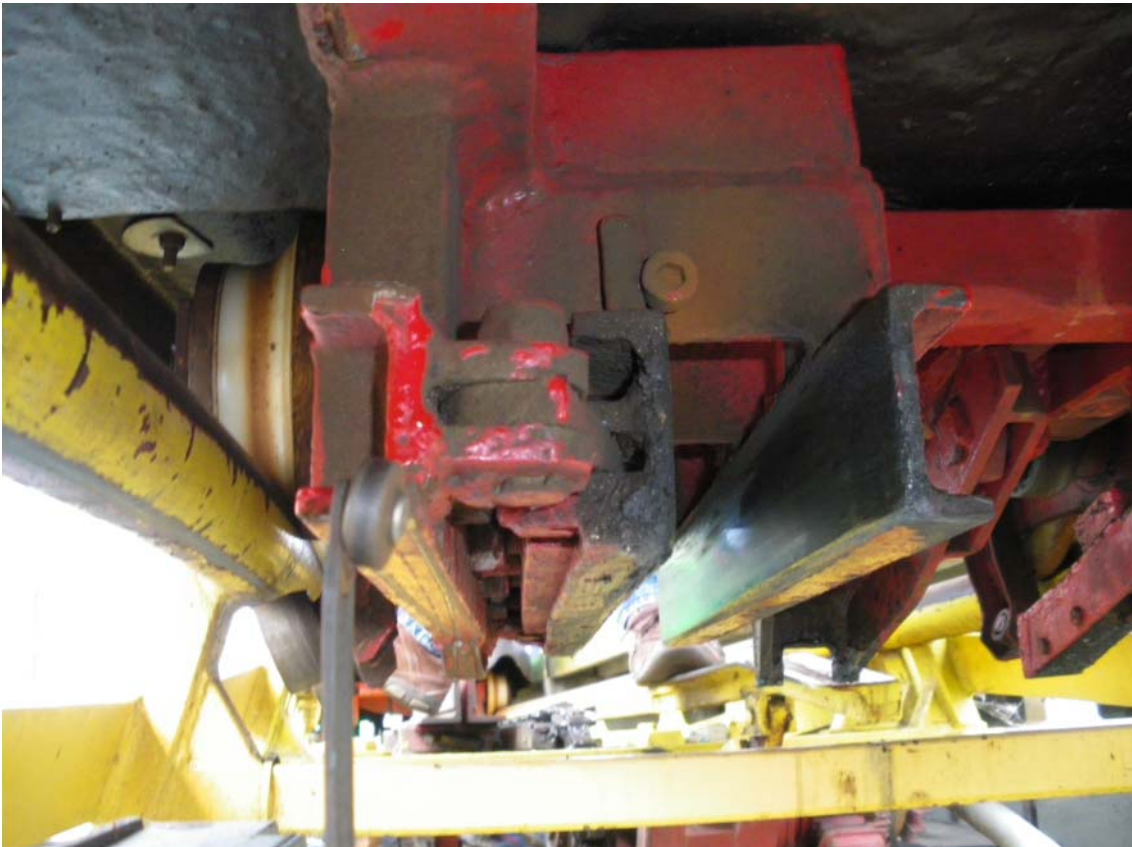
Fig 4.

Fig 4 is a photo taken underneath a car showing the metal plates which engage the chain brake system and it is also these plates that operate the sensors when necessary
