NAFLIC

TECHNICAL BULLETIN — June 2016

405. Intamin Drop Tower seat bracket cracking

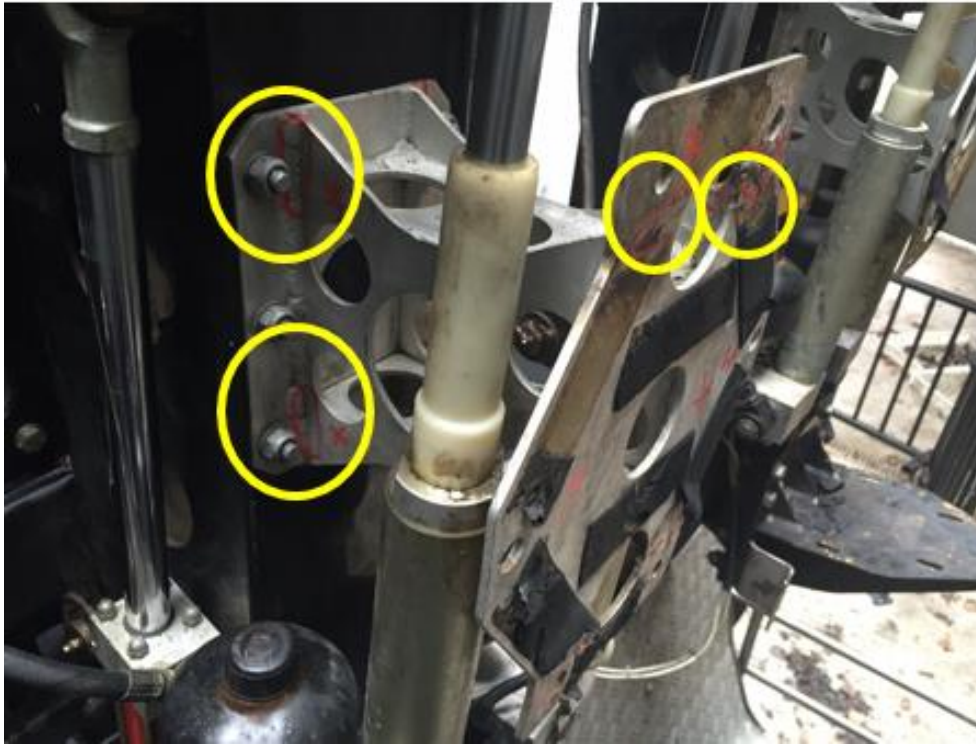
Bracket installed on the Kart

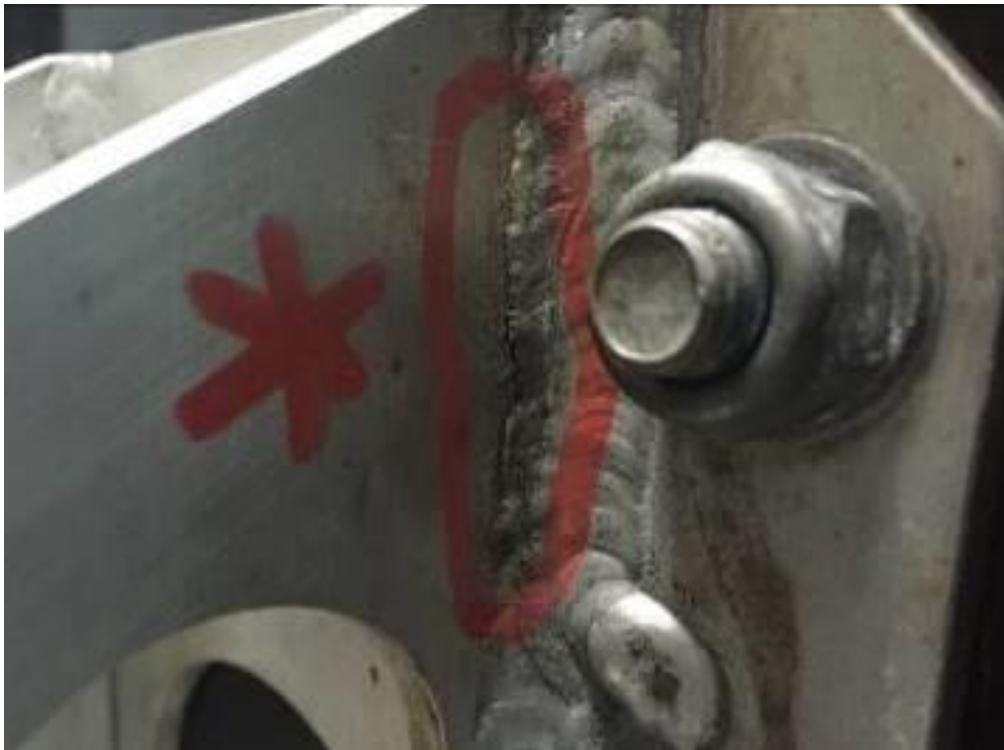
We have received a report from a UK registered inspection body that numerous areas of cracking have been found on the seat brackets on an Intamin Drop Tower ride. These areas of cracking were found by Visual Examination and Dye Penetrant Testing and are in unexpected areas.

Cracking on a vertical weld – found by DPI

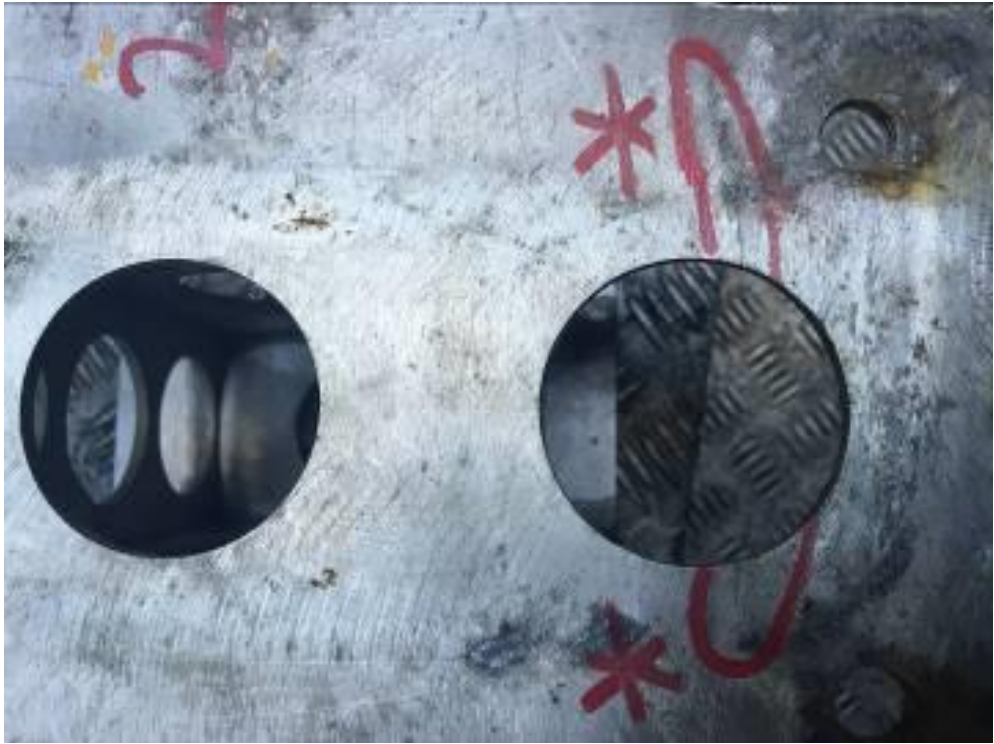
Cracking on the rear of the bracket found visually

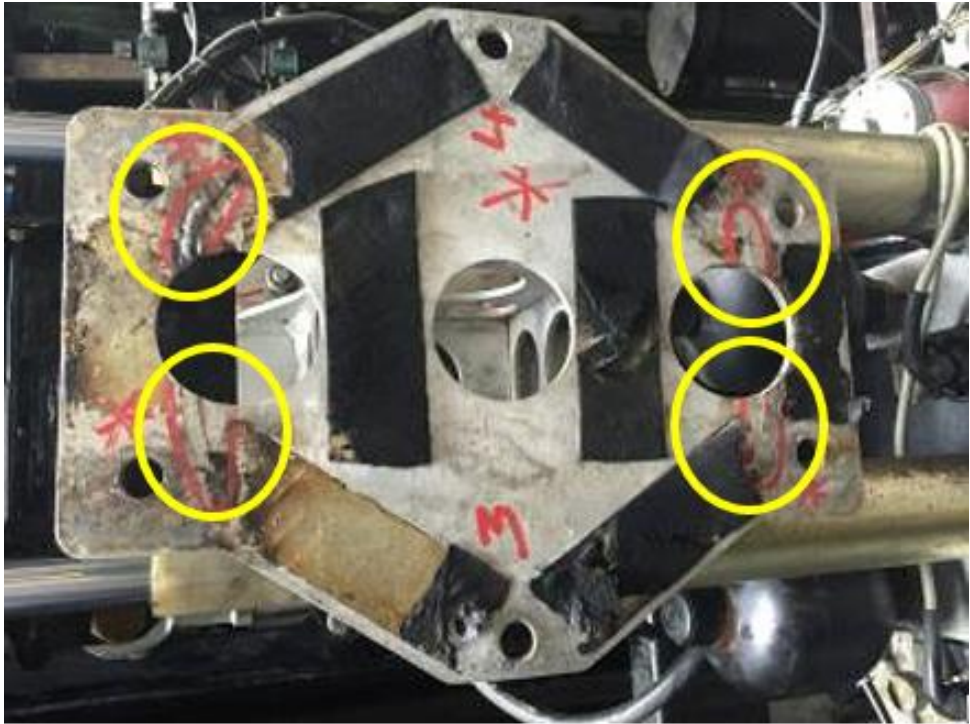
Cracking on the front of the bracket found visually
