Bolliger & Mabillard inverted coaster vehicle seat columns

SERVICE BULLETIN

Item: Vehicle seat columns

Bulletin No.:	15
Release Date:	February 22, 2018
Effective Date:	February 22, 2018
Supersedes:	none
Issued by:	J.B. Calvet
Checked by:	E. Berra
Page:	2 of 2

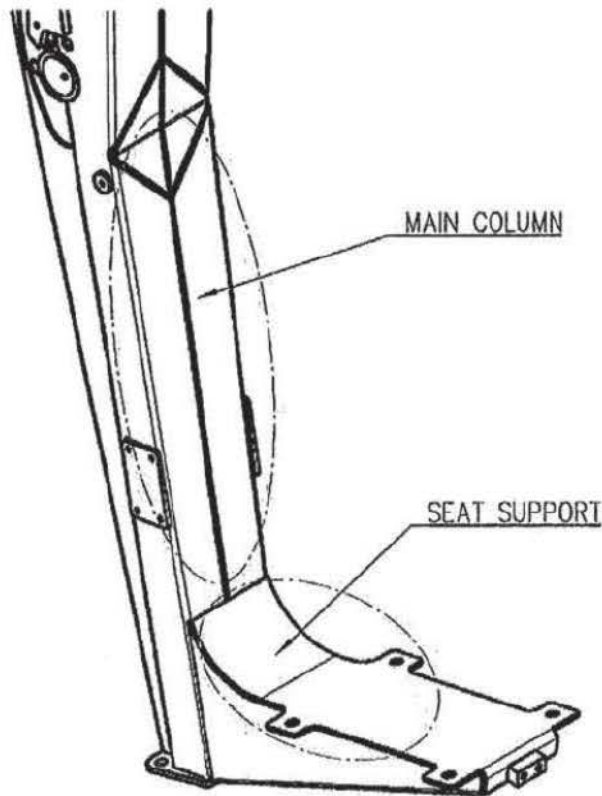
Detail of Issue:

Visual inspection after dismantling of the seats and seat backs.

1. Within 10 days, the components attached to the seat columns shall be dismantled to allow the NDT and visual inspection as per the Detail of Issue.
2. Renew if necessary corrosion protection.
3. Significant loss of material thickness (above 0.6 mm on the main column or above 0.8 mm on the seat support) dictates columns replacement.
