479.

Twist cracking

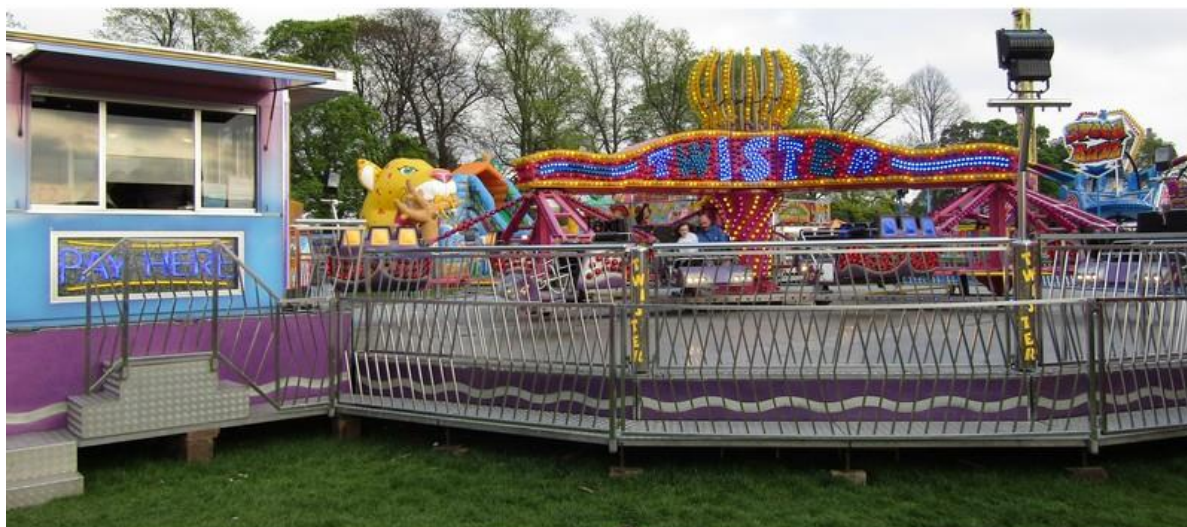
JC NDT has found cracks on 11 out of 12 twister car foot rest attachment welds on a Twist ride.

The area in which the cracks were found is highlighted in red on the attached Twist ride image (please note the image is not of the actual device in question; this is for reference/illustration purposes only).

The device the cracks were found on was built by Heath Engineering but it is believed that most devices are of a similar design (if not identical as a lot of Twists were built under licence).
