480.

Zamperla Air Race – themed wing failure

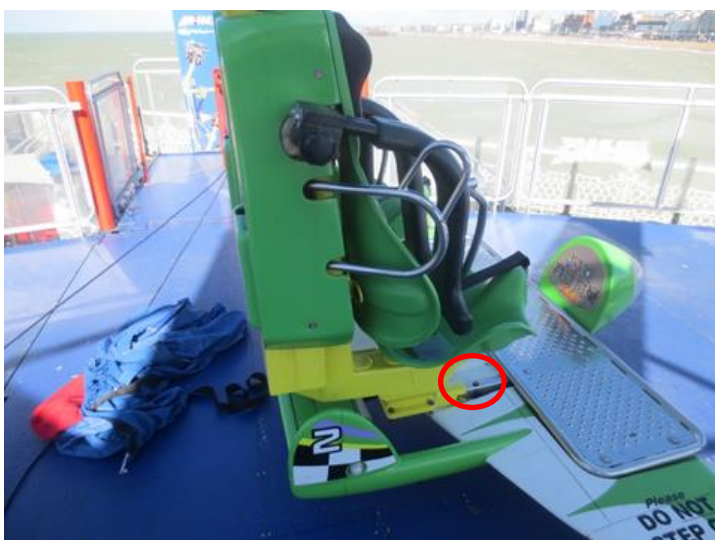
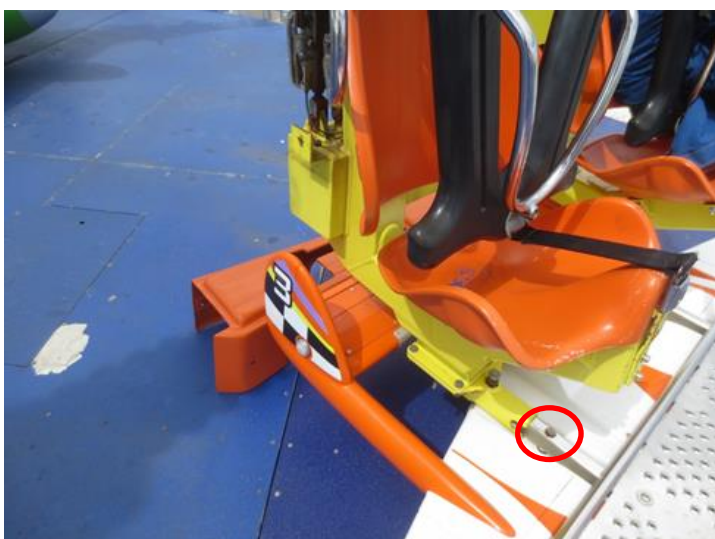
NAFLIC has been advised of a failure on a Zamperla Air Race (trailer mounted model) manufactured in 2012, where the lower themed wing, attached to the underside of the seat unit, became detached during operation of the ride. Initial investigations show that the failure was at the bolted connections securing the themed wing section to the supporting box section (see areas highlighted below).

While it is noted that the park model detail of this connection is of a slightly different design, this area on all Zamperla Air Race models, fixed park and trailer mounted, should be visually checked to ensure there are no cracks present. The visual inspections should be supplemented by NDT as recommended by your Inspection Body. How this is then inspected going forward to ensure its continued integrity should be discussed and agreed with your Registered Inspection Body.

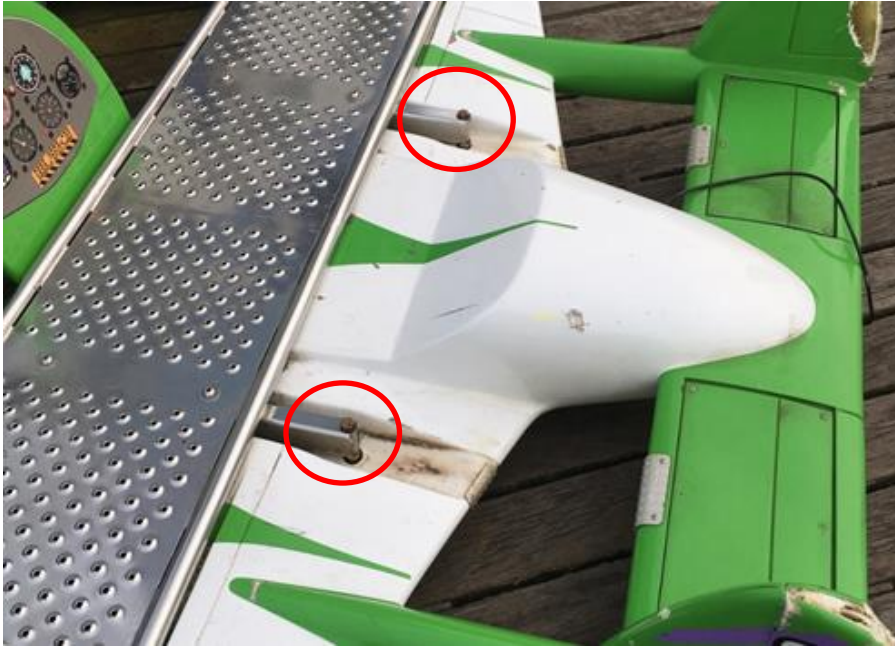
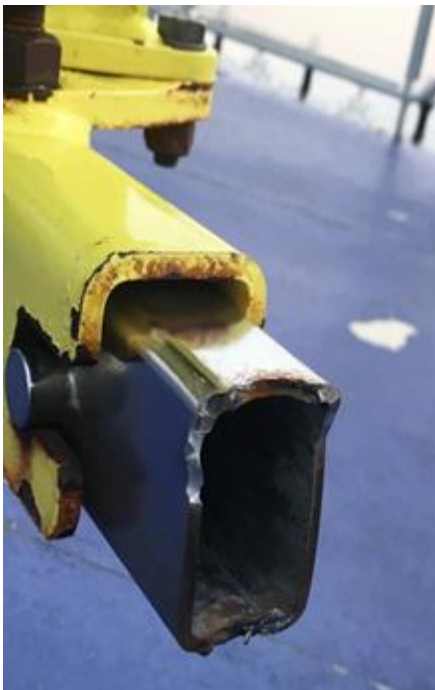
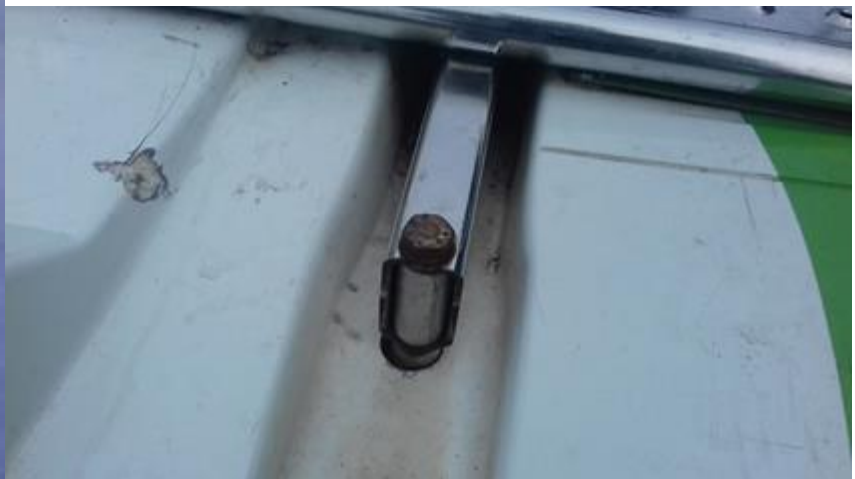
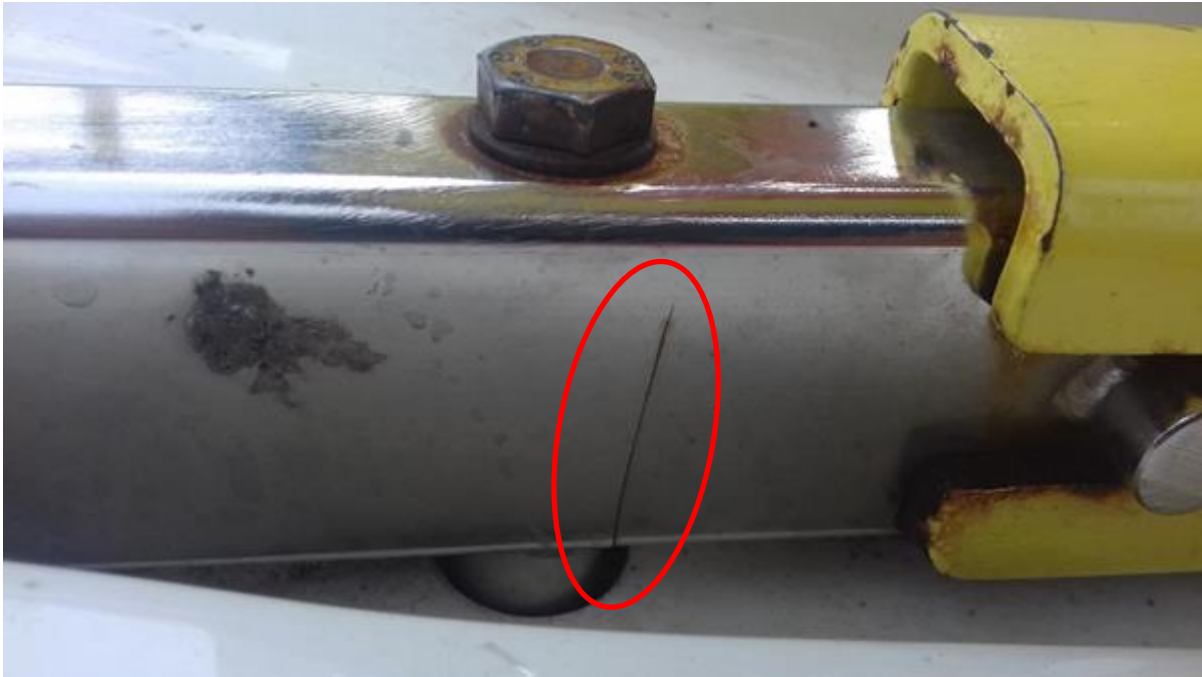
It is noted that when manufactured, the box section through which the securing bolt is located has been strengthened by the fitting/inserting of a bush that has been secured with a circumferential weld top and bottom. The crack(s) appear to have initiated in these circumferential welds and then propagated along the side(s) of the box section until failure (see photos below).
