TECHNICAL BULLETIN — February 2015

384. Vekoma restraint ‘E-block’ cracking

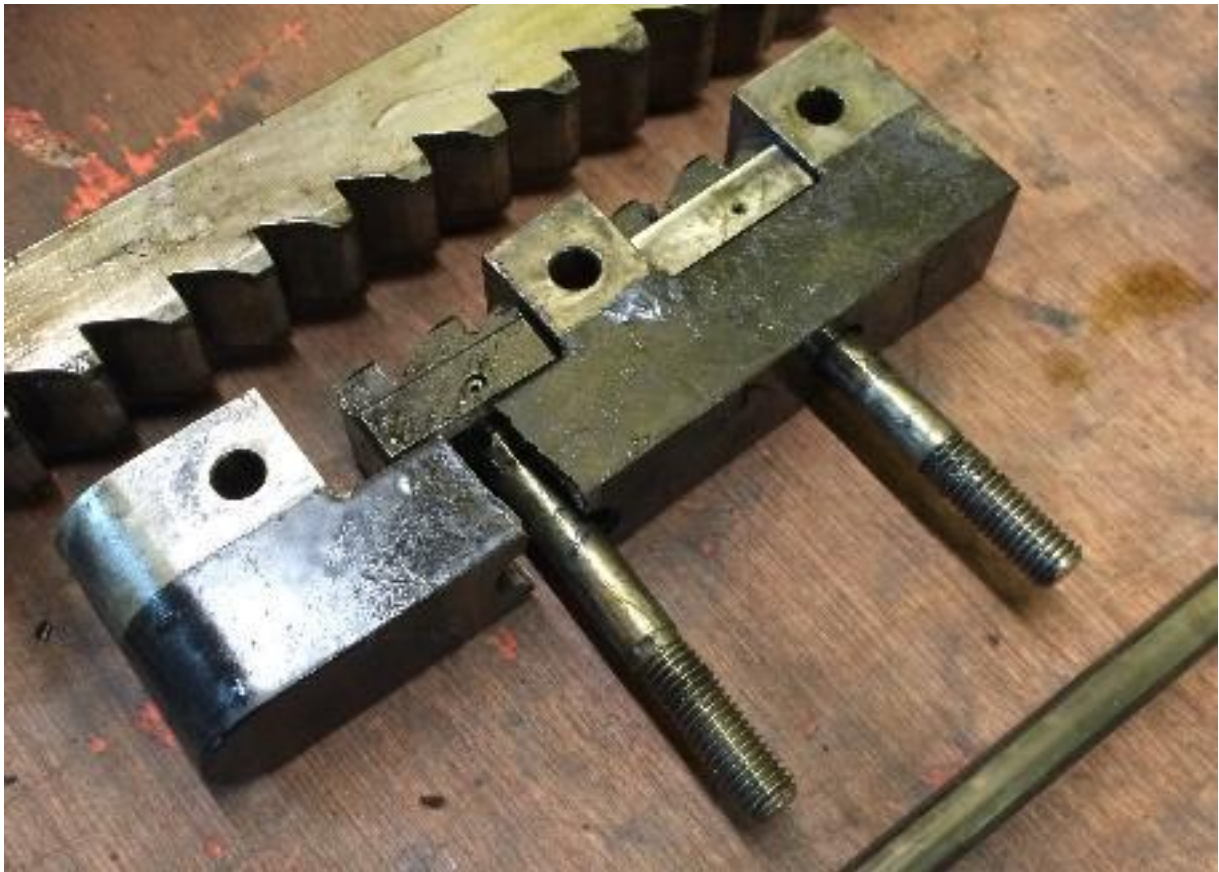
Cracking has been identified on the “E-blocks” which form part of the locking mechanism for the shoulder harnesses on a Vekoma suspended looping coaster. In one instance (pictured) the E-block had completely failed. The cracks appear to have initiated on the inside face of the “E-block”, around the edges of the locating hole for the pawl stem. Although this failure was found on a suspended looping coaster, it is understood that this system is used on a variety of Vekoma rides. Inspection bodies and controllers are advised to pay particular attention to these components during annual inspections and routine ride checks.
